**DAMAGE IN SCHOOLS
IN THE 1998 FAIAL EARTHQUAKE
IN THE AZORES ISLANDS, PORTUGAL**

**Jorge Miguel
Proença**

*Institute of
Structures, Territory
and Construction
Engineering, Higher
Technical Institute,
Portugal*

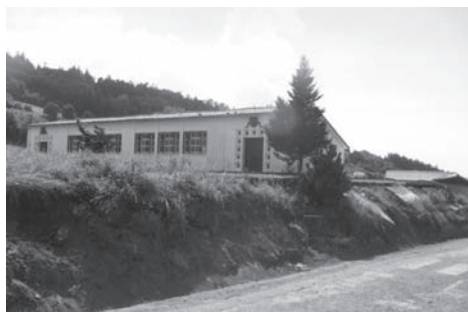
Figure 8.2 – a two classroom, one-storey, early reinforced-concrete school in Espalhafatos – shows one of the most common solutions for educational buildings. The school building design and construction is similar to that found in Salão, Capelo, Lombega and Feiteira (Rua da Portela).

Figure 8.2. Overview of school at Espalhafatos

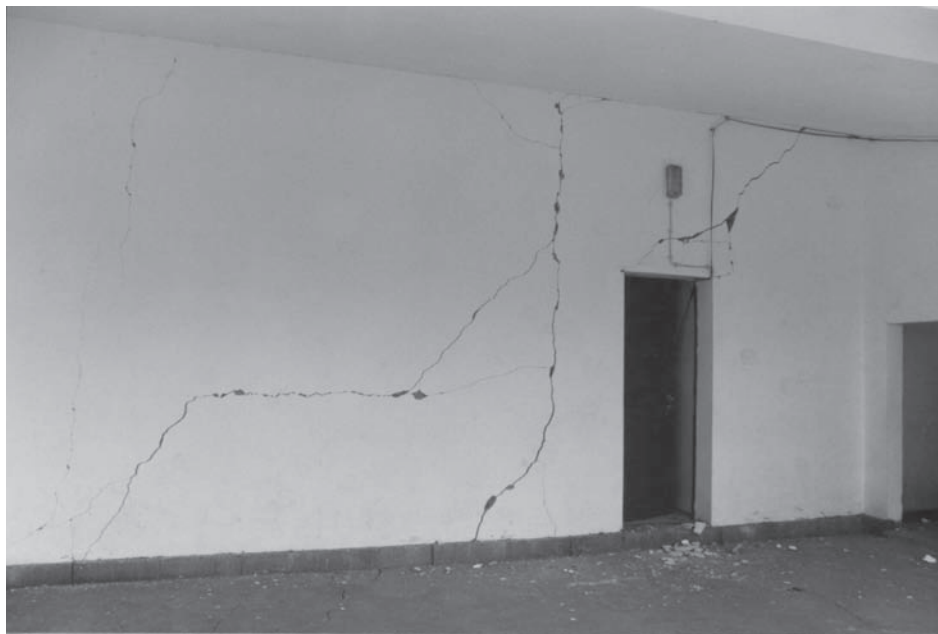
Espalhafatos	VII	Early reinforced concrete	High	Average	1	Damage at corners with separation between masonry and reinforced-concrete elements, damage at the column bases and cracks in external walls	Cracking in partition and external walls and floor settlement	Damage in external retaining walls	Use after extensive repairs
Salão	VII	Early reinforced concrete	High	Average	1	Damage at the columns	Cracking in partition and external walls and cracking in the connection between floors and walls	Damage in external retaining walls	Use after moderate repairs
Salão (kindergarten)	VII	Masonry wall	Medium	Average	1	External wall collapse	General damage	General damage	No use, demolition
Cedros	VI	Early reinforced concrete	High	Good	2	None	Cracking in partition and external walls	Cracking in external retaining walls	Immediate use
Cascalho	V-VI	Frame reinforced concrete	High	Good	1	Slight cracking in reinforced-concrete roof beams	Slight cracking in partition walls	Cracking in external retaining walls	Immediate use

Figure 8.3. Severe cracking in internal partition walls at school in Espalhafatos

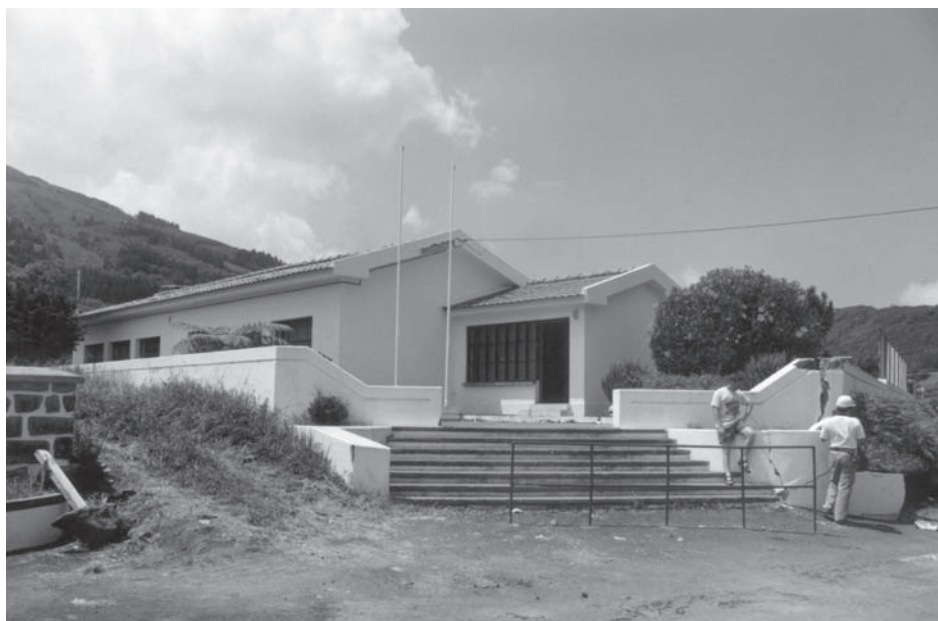
Figure 8.4. Damage in reinforced-concrete roof beams and in retaining walls at school in Ribeirinha

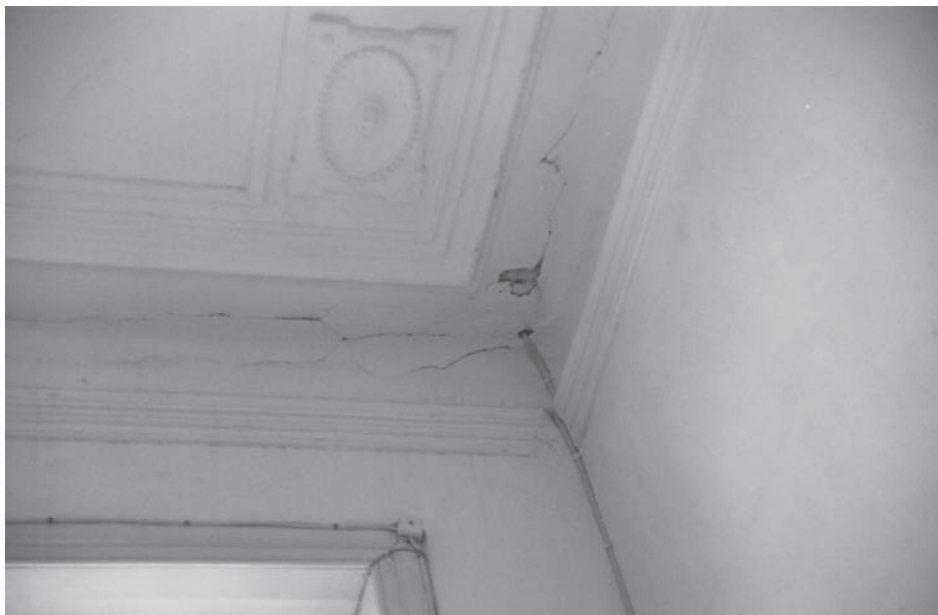
Figure 8.5. Cracking of stucco ceiling at Horta (Coronel Silva Leal) school

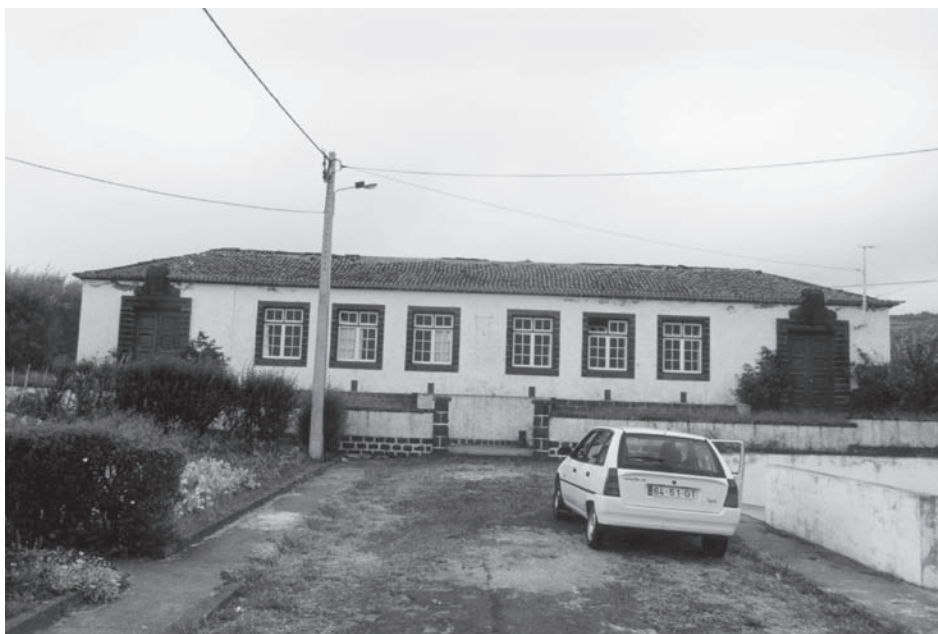
Figure 8.6. Dislocated roof tiles at Castelo Branco (Carreira) school

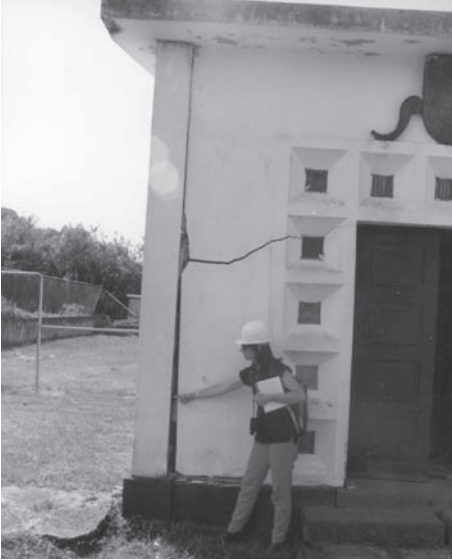
Figure 8.7. School in Espalhafatos: Separation between block masonry and reinforced-concrete elements

The extent and nature of damage in these educational buildings was strongly influenced by the structural solution. In recent reinforced-concrete structures, cracks were observed in structural elements, such as columns. Other side-effects were also noted, such as pounding and the development of short-column phenomenon resulting from partial, initial or damage-influenced restraint by adjacent non-structural masonry walls. In masonry structures, cracks of varying widths and extensions were observed in external and internal walls. Damage in early reinforced-concrete structures was similar, although less pronounced, than damage detected in masonry structures, with some signs of separation between the block masonry and reinforced-concrete discrete elements.

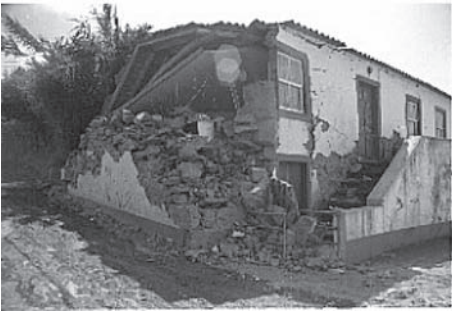
Figure 8.8. Collapse of external rubble masonry walls in kindergarten in Salão

in the "other" category was the collapse, cracking or overturning of earth-retaining walls, generally made of rubble masonry. This was caused by the fact that the buildings were generally constructed on relatively steep slopes. Dislocated tiles were also found on a number of educational buildings.
