**EARTHQUAKE VULNERABILITY OF SCHOOL
BUILDINGS IN ALGERIA**

**Fouad
Bendimerad**

Abstract: This paper describes the nature and cost of damage to school facilities in the 21 May 2003 Boumerdes earthquake and other earthquakes in Algeria. It provides statistics on the extent of damage and estimated costs of reconstruction and rehabilitation. The author discusses the factors that increase the vulnerability of school construction in Algeria, such as urban development, structural flaws in existing school building stock, and inadequacy of building codes and construction control for school buildings. Approaches to reduce the vulnerability of both existing and new school buildings are also presented.

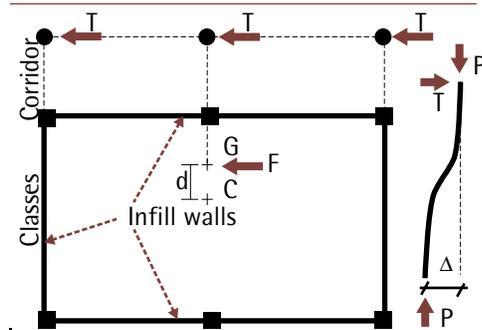
Figure 1.1. Illustration of torsional forces and P-Δ effects

- The open corridor in the front of the building creates an offset between the centre of mass and the centre of rigidity of the building, as shown in Figure 1.1. This results in torsional effects that increase the loading on the building's exterior columns. Often, these loads

are not accounted for in design and can lead to additional damage and eventually failure of the columns.

- Design ground motions specified in the code should be increased to reflect the actual hazard conditions of the country. Design hazard levels should include the seismic contribution of the active tectonic of northern Algeria, in addition to the uncertainty deriving from the lack of knowledge about the seismic potential of the country, which has been neglected in previous studies.
- A lateral system based on concrete shear walls – especially in the transverse direction of the building – would be preferable to the current frame system. Such a system would also be more reliable considering the lack of earthquake engineering expertise in Algeria.
- The current reinforced-concrete frame system could remain in use, but its design should follow strict requirements to ensure ductile behaviour and to take into consideration torsional effects and stability requirements.

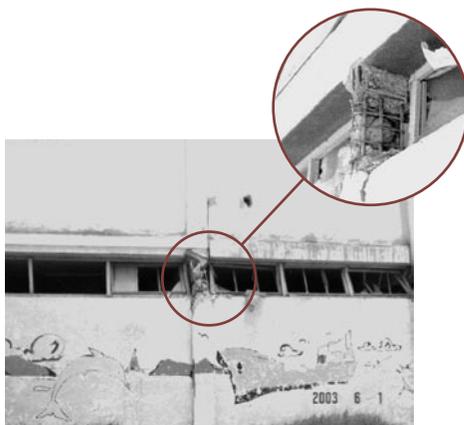
- The narrow windows ("vasistas") on the back wall create so-called "short column" conditions for the portion of the column that extends above the wall and below the floor. These short columns are subject to high shear stresses because of the restrictions imposed by the walls below the windows. During the design process, the walls are ignored because they are considered to be "non-structural", and consequently the shear stresses are underestimated, leading to failure as illustrated in Figure 1.2.
- The L- and U-shaped configurations also create some additional weaknesses in the seismic ability, where stress is concentrated in the corners of the building (re-entrant corners) and can lead to failure if not properly designed.

Damage patterns from past earthquakes have consistently demonstrated the consequences of the flaws in design and construction. Extensive damage was observed in the non-ductile concrete frames, including crushing and cracking of concrete and buckling of steel bars in the columns due to lack of transverse confinement and improper longitudinal reinforcement of joint connections (Figure 1.3). Other types of failure include shearing in columns with a clear indication of a strong beam/weak column approach, and minimal ductility. Failure in the columns sometimes causes partial or total failure of the first floor (Figure 1.4). Failure of short columns is also widespread and has been reported in each major earthquake (Figure 1.2). Cracking of masonry infill walls was also reported. The extremely poor quality of concrete is another factor in the failures.

Figure 1.2. Concrete cracking on short column along back wall

- Design should eliminate short-column conditions.
- A system of construction control and building code enforcement should be put in place to ensure the quality of design and proper building practice. Designers and contractors should be adequately trained and qualified, preferably licensed, to design and build schools.
- The Ministry of Housing should establish an office for construction control and enforce stronger technical requirements in its procurement procedures.

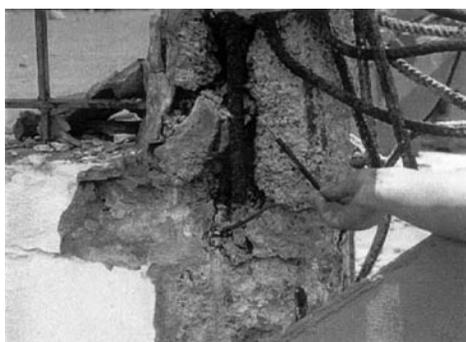
Figure 1.3. Failure of columns at joint

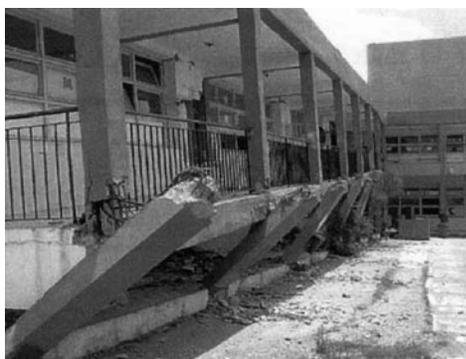
Figure 1.4. Collapse of first floor due to column failure

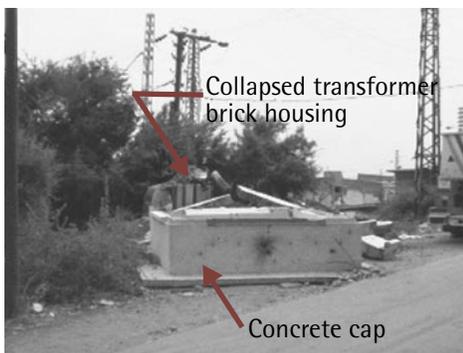
Figure 1.5. Concrete cap thrown from its original location

region exceeded 100% of gravity. As shown in Figure 1.5, the concrete cap of this transformer housing was overturned and thrown about 2 m from its location, indicating that both the vertical and horizontal motion exceeded 100% of gravity. Hence, the underestimation of the ground motion input in the code consistently results in school structures with lower earthquake capacities than the potential demands from earthquakes. Even under the best circumstances – *i.e.* good concept, good design and good construction – this underestimation translates into high vulnerability.
